**SAS Superstructure**

Location: 04-SF-80-13.2 / 13.9

Daily Diary Report by Bid Item

**04-0120F4
04-SF-80-13.2/13.9
Self-Anchored
Suspension Bridge****Weather**

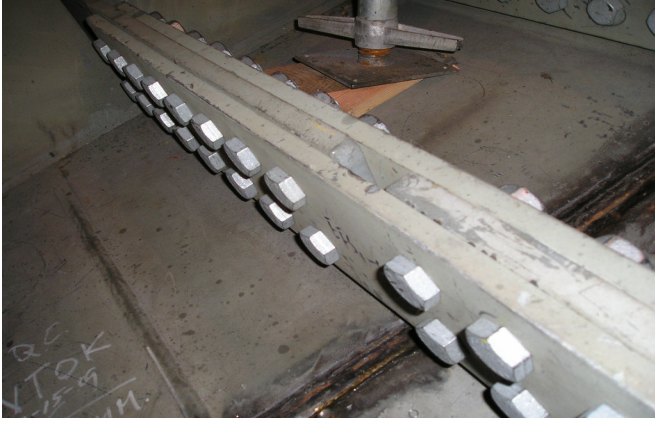
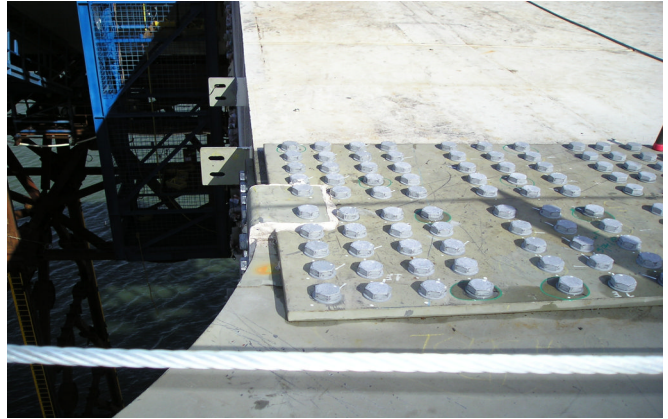
1- Punch list item # 1661 (damaged rib stiffener)

· The rib type connection was checked with respect to ABF-RFI-001931R00. The location of the connection was identified with the help of drawing # SP389 of this RFI. The connection was checked for both vertical and longitudinal alignment, and no abnormality was observed. Please see the attached pictures. The RFI specifies the repair of the damaged rib stiffener; we have not observed any replacement of the damaged rib stiffener. Another check is planned for tomorrow March 31, 2010.

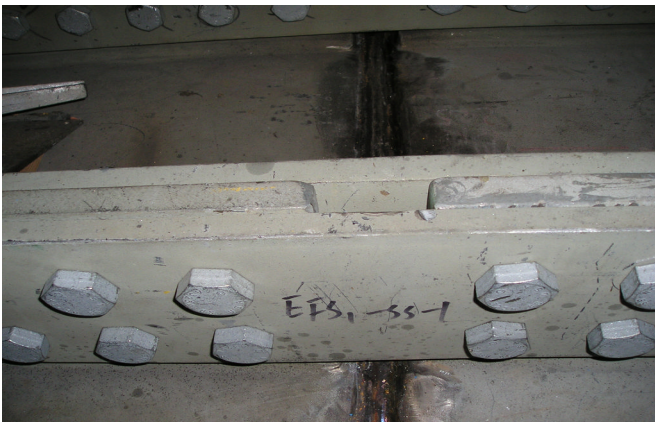
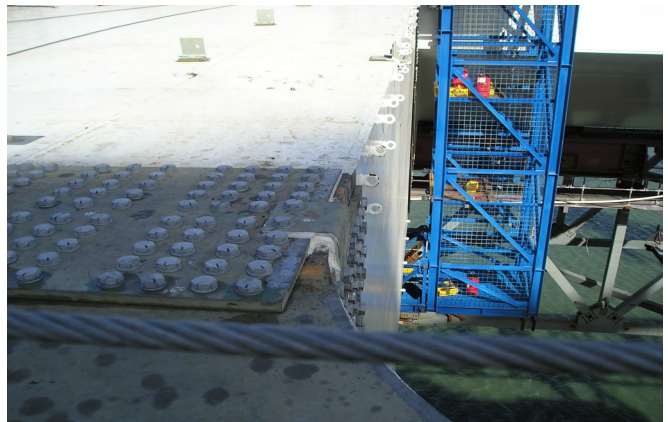
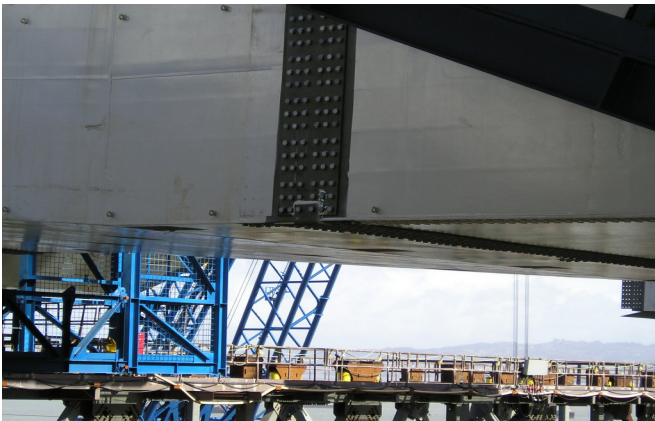
2- Crossbeam Seal Plates

· Besides of the Z shape seal plates located at the bottom of the CB connection to OBG, there are another 12 seal plates, 4 at each CB splice point, 2 at the top and 2 at the bottom. Then for 2 CB splices there are 8 seal plates. There are also 2 seal plates at the top of CB connection to OBG at the splice plate location for each side, total 4 seal plates for both sides. All the sealing plates detail can be found on Sheets 661/1204, Detail A, 662/1204, Detail A, 664/1204, and 722S1C/1204, Detail A of the contract plan.

· Only 3 seal plates are assembled with caulking to prevent any water leakage. 2 at the top connecting the CB1 to Lift 2E and one at the bottom at the CB1 splice location. Please see the attached pictures.
